REPAIRCERT NZ UPDATE

UPDATE No. 13 | 15/09/2022

Case Study: 'Water Damage' Versus 'Water Ingress'

Correct Aperture Preparation for Bonded Glass

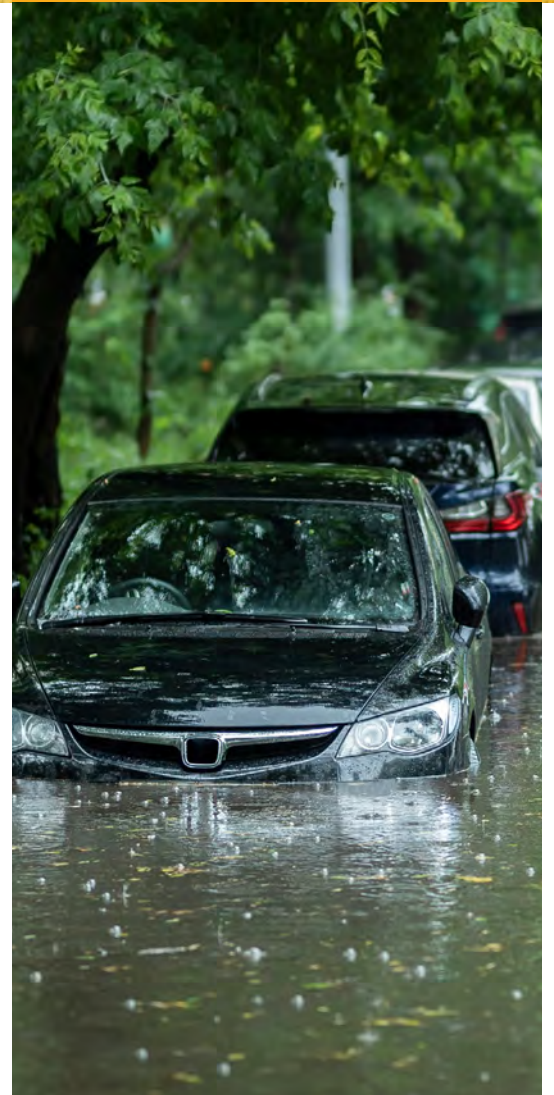
The Repair Certifier determined that the vehicle required repair certification, and took on the job. Complications arose during the second repair certification inspection of the vehicle, when the Repair Certifier 'discovered' (excuse the pun!) that there was now a relatively small volume of water accumulated in the centre floor pan (at the lowest point of the vehicle cabin area). In this vehicle, the floor coverings are a combination of carpet and heavy-duty insulation materials that had also soaked up some of the water.

Because the water was not present during the Repair Certifier’s first inspection, the Repair Certifier’s view was that the vehicle had not been submerged, and had not sustained ‘water damage’, but rather, had some ‘water ingress’ for some reason (unknown at the time).

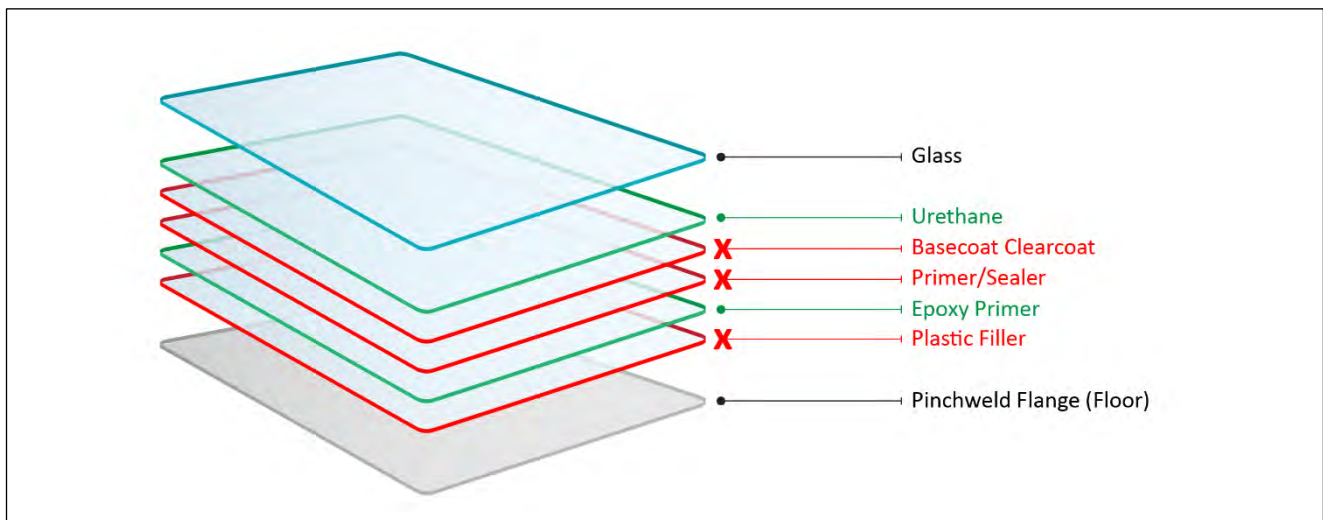
Commonly, repairers are refinishing the entire window aperture (including the pinchweld flange areas) prior to the installation or reinstallation of bonded glass.

This practice is incorrect because the presence of plastic fillers, primer-sealers, and top-coats between the pinchweld flange and bonding materials creates weaknesses that could have safety consequences on vehicles that utilise bonded glass e.g. virtually all of our modern fleet.

The diagram below shows the steps (in red) that **MUST BE LEFT OUT** when fitting bonded glass.

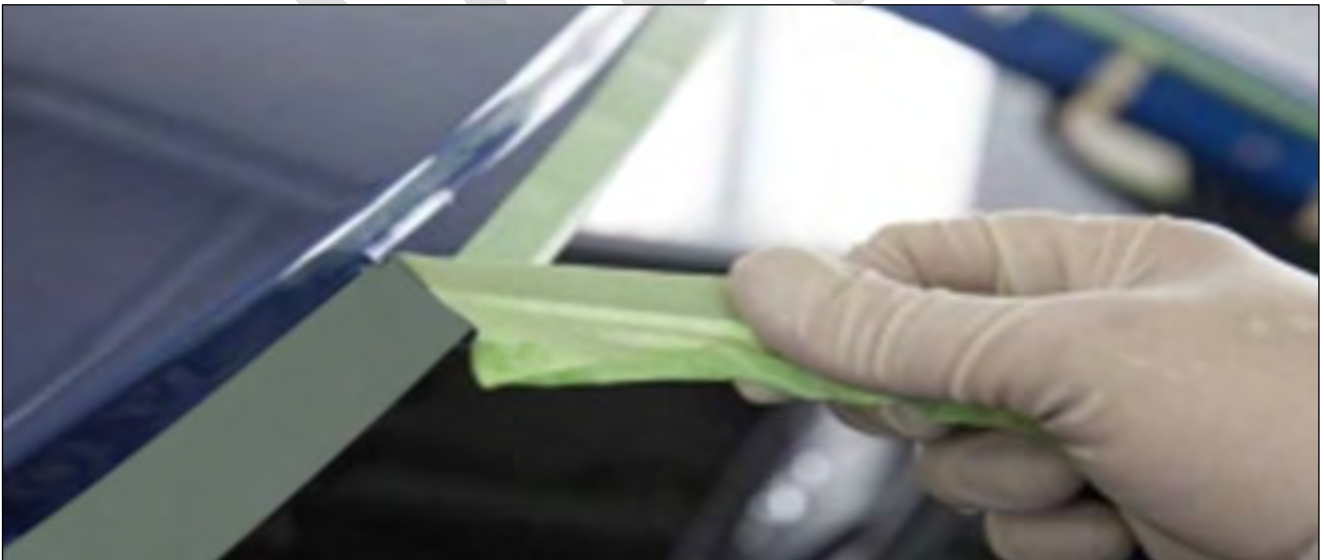
After full curing, the epoxy primer-coated pinchweld flange floor area (where the new urethane bead will be positioned), is masked off to prevent contamination and overspray from sealers and topcoats that will be applied to the body during the refinishing processes.

THE ONLY COATING APPLIED TO THE PINCHWELD FLANGE FLOOR IS EPOXY-PRIMER.

Damaged or removed OEM E-coatings and all other correctly prepared bare metal surfaces, must be primed or ‘sealed’ with an epoxy primer. Note that:

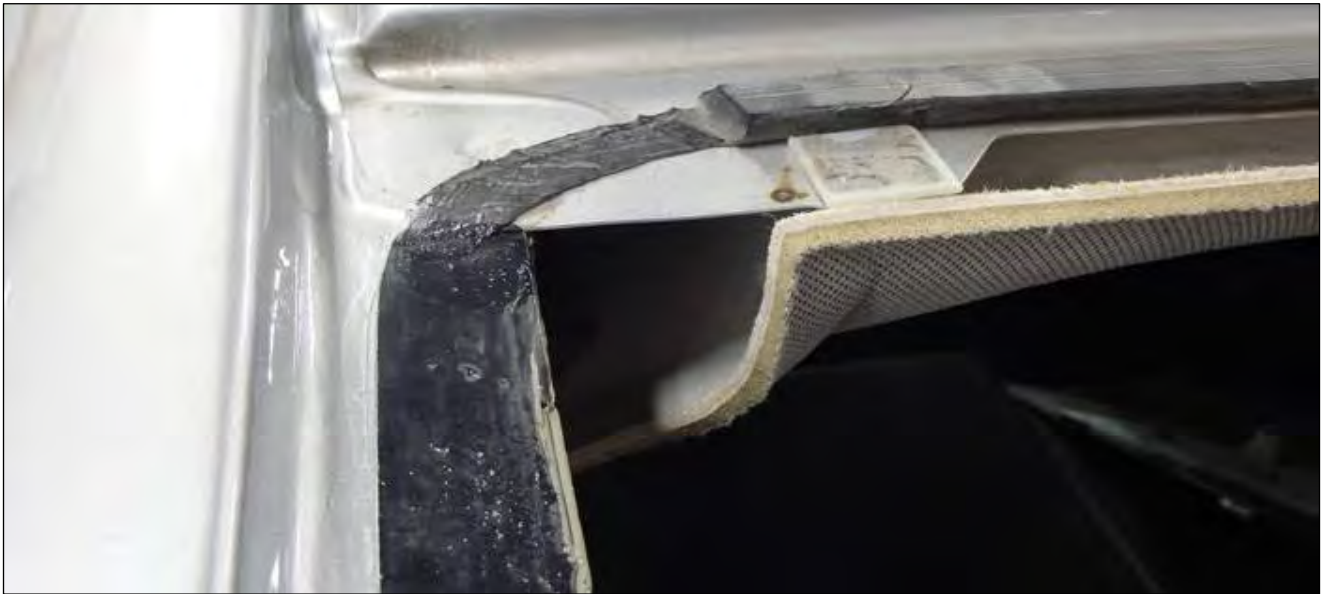
Pinchweld Inspection and Preparation: Close-cut the original urethane down to a thickness of 1 mm - 2 mm. Clean with water and dry with a clean cloth. Apply pinchweld primer to any bare metal scratches if necessary and allow to dry for 10 - 15 minutes.

- The retention of the original urethane bead also increases the adhesion performance of new materials when applied directly to the existing urethane adhesive bed - *urethanes adhere best to each other (100% 'bond entanglement')*.
- The epoxy primed areas, along with any bare metal scratches, must be primed with the appropriate pinchweld primer, and allowed to dry (typically around 10 to 15 minutes).
- Directly before the application of new urethane, the original urethane bead is trimmed back to a uniform thickness of 1 mm -2 mm, cleaned with water, and dried with a clean cloth.
- The new urethane adhesive bead is then applied either to the pinchweld floor, or to the prepared glass, prior to installation.
