# REPAIRCERT NZ UPDATE

UPDATE No. 14 | 25/10/2022

## Technical Bulletin # 3 - 2022 Correct Aperture Preparation for Bonded Glass

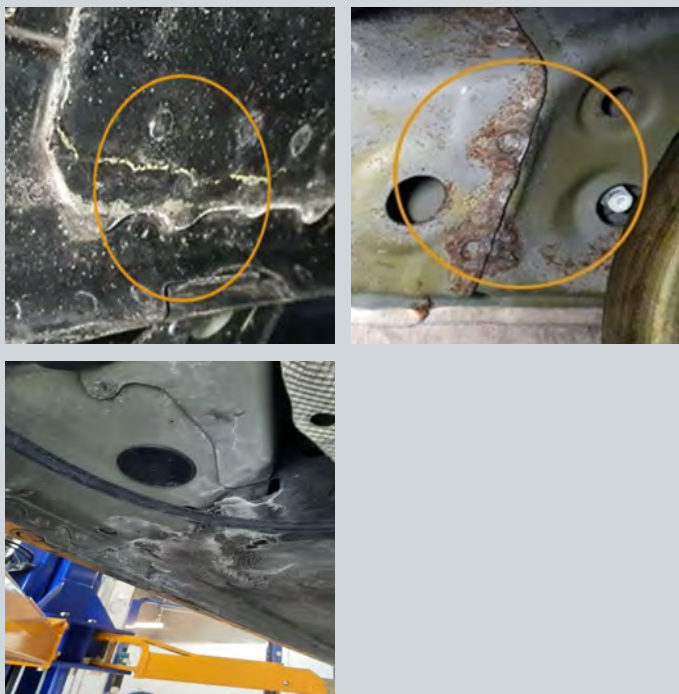
*Acid washing is a treatment being used to repair corrosion in vehicles, in particular the underbody structure and components. The process involves the use of a chemical mix containing an acid base liquid, phosphoric acid is commonly used, to remove corrosion and treat the metal area. The following photos show examples of visible signs of acid wash repair.*

Visible signs of an acid wash repair include:

- The area has been cleaned and a clear topcoat, or no topcoat applied.
- A white residue is noticeable in joints, seams, or coming through underseal/topcoats.
- Corrosion is still visibly active in an area that has been treated.

An area of metal that has not been acid washed correctly will continue to degrade within a short time and can be detrimental to the vehicle structure.

When visible signs of acid wash repair as described above are observed by an inspector at an entry compliance inspection the vehicle must be failed and referred to a Repair Certifier for assessment.

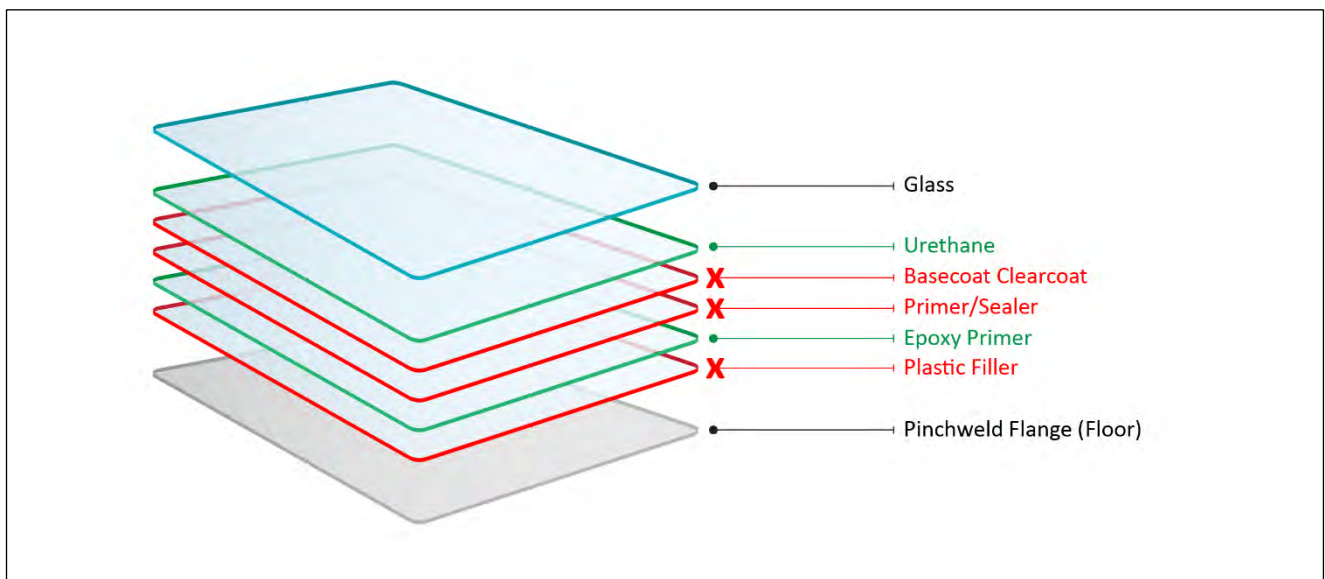
**Diagram 1.**

RepairCert NZ has become aware that a fundamental mistake is being made by a significant proportion of the repair industry when installing or reinstalling bonded glass. Commonly, repairers are refinishing the entire window aperture (including the pinchweld flange areas) prior to the installation or reinstallation of bonded glass.

**Diagram 1 below shows the steps (in red) that MUST BE LEFT OUT when fitting bonded glass.**

- As shown in Diagram 1 (page1), and Diagram 2 (below), there should be no other coatings between the urethane and pinchweld flange other than epoxy primer.

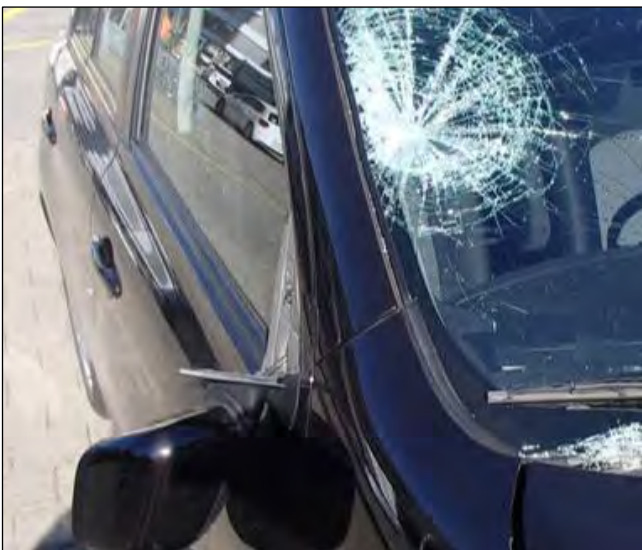
*Image 1.*

1. glass replacement for damage (cracks and chips as shown in *Image 1*); or
2. removal and refitting for re-finishing operations (especially where masking in-situ processes are not appropriate e.g., lifetime paint warranties as shown in *Image 2*); or
3. removal and reinstallation for panel damage and panel replacement, in the location/proximity of where the glass is fitted as shown in *Image 3*; or
4. removal and re-installation to repair corrosion damage in the area where the glass is fitted as shown in *Image 4*.

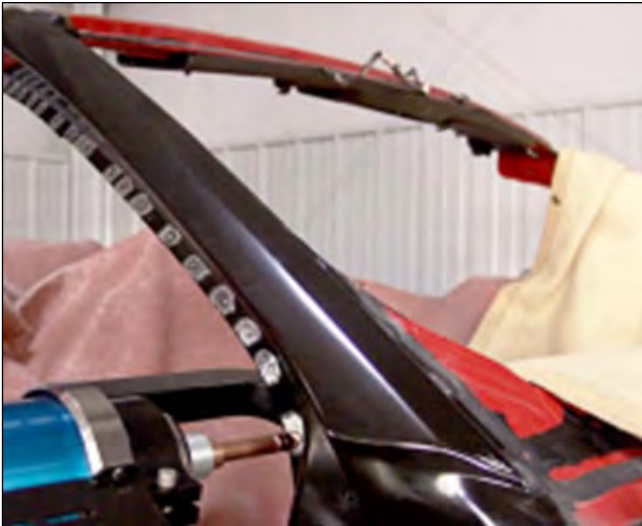
Image 3.

Points 3 and 4 above (part replacement/repairs and corrosion) are typical situations where the bonding surfaces (pinchweld flanges) will by necessity be substantially affected and accordingly require different surface preparations.
