REPAIRCERT NZ UPDATE

UPDATE No. 15 | 21/11/2022

Sectioning and Partial Replacement of Outer Panels

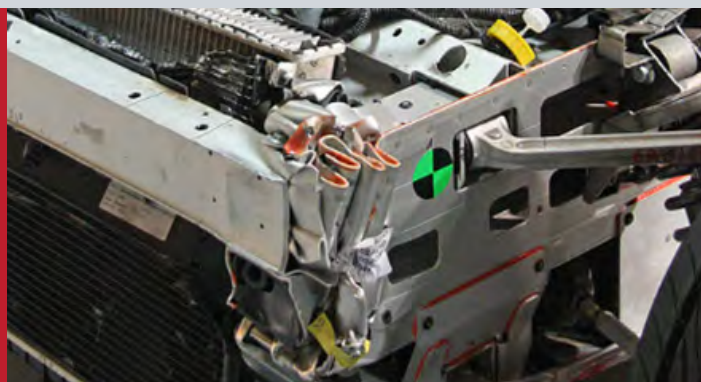
Image above: Typical (albeit dramatic), example of a crush zone performing its intended function during an impact.

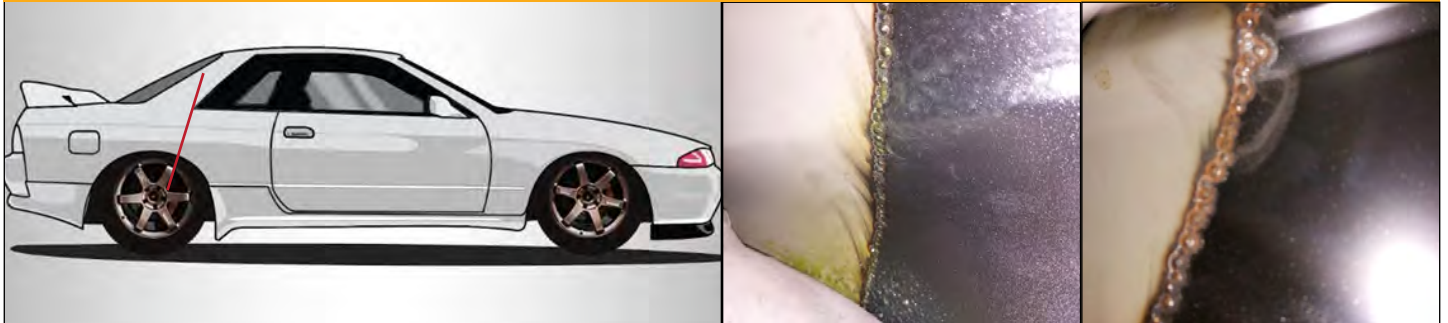
Case Study 1: Nissan Skyline Coupe

Image left: The front portion only of the outer rear quarter has been partially sectioned (cut and join location shown in **RED**). **Image middle and right:** Interior inspection of the welded joint(s).

- determine the tensile strength of the outer panel (in most instances, exterior panels are manufactured from mild steels [under 250 MPa]), which does not require the more specialised welding techniques typically used to avoid compromising weld joint strength when welding higher tensile strength steels; and

- be satisfied the welding processes that have been used are fit for purpose, with a visual inspection to determine the appropriate penetration (weld strength); and

- ensure corrosion protection has been, or is able to be, restored; and
- confirm the Original Equipment Manufacturer (OEM) has no warnings or cautions against performing this type of repair; and

- make sure the sectioning joint locations are not in areas where welding heat (the heat affected zone [HAZ]), may adversely affect adjacent reinforcements or inner structures (especially those that are made from high strength steels [HSS]); and

- ensure any seatbelt anchorage systems have not been affected in the area(s) where the weld joints are located; and
- confirm any noise vibration harshness (NVH) components affected by the repair are replaced, or re-fitted, as per OEM requirements; and

- be satisfied that any adhesive-bonding, rivet-bonding or weld-bonding areas (as used by the vehicle manufacturer, or required in a replacement procedure) have been, or are able to be, installed as specified by the OEM.

- When the Repair Certifier is satisfied that all of the above criteria have been verified or any faults rectified, this type of repair can be approved. ■

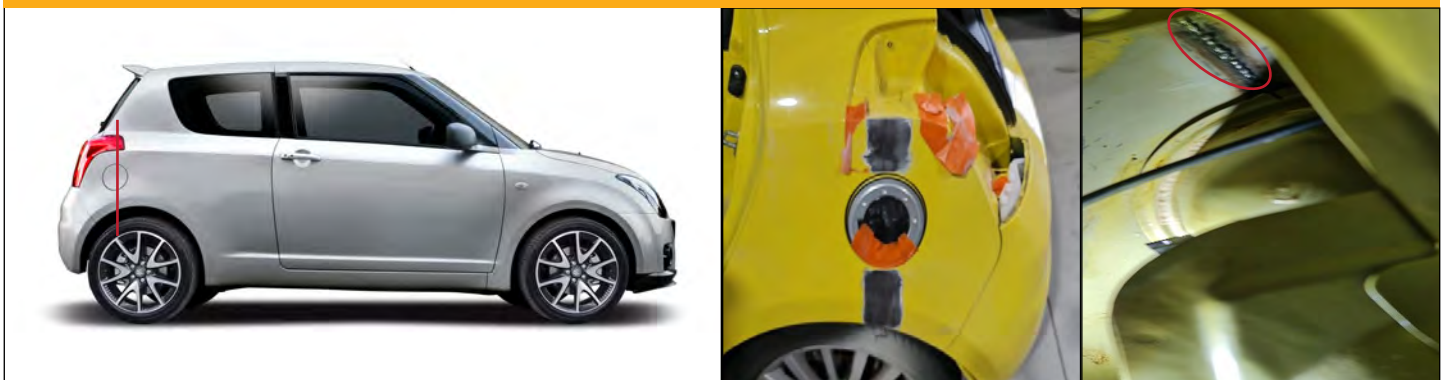
Case Study 2: Suzuki Swift

Image left: The rear portion only of the outer rear quarter has been partially sectioned through the middle of the fuel filler pocket (cut and join location shown in **RED**). **Image middle and right:** Exterior and Interior inspection of the welded joint(s).

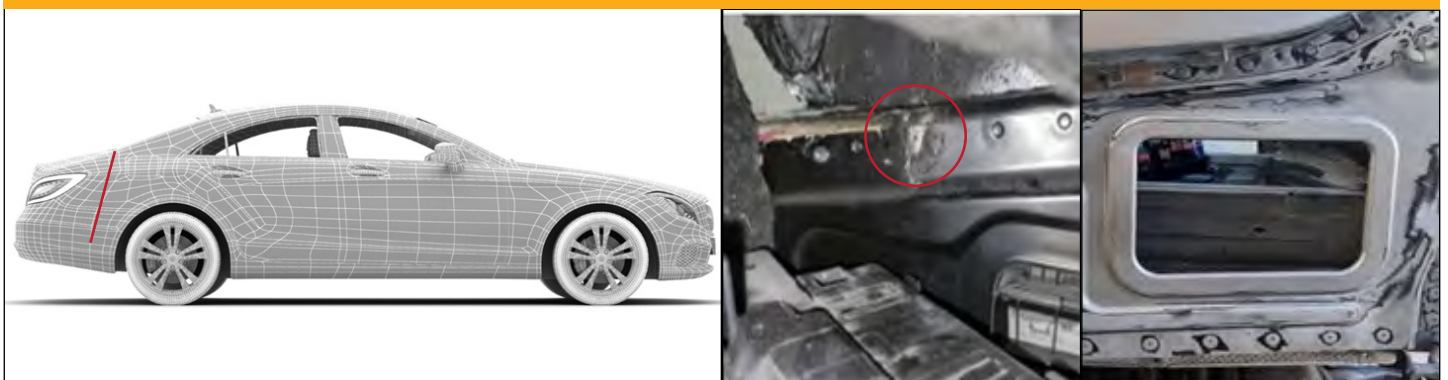
Case Study 3: Mercedes Benz S400

Image left: The rear portion only of the outer rear quarter panel has been partially sectioned rearward of the C pillar (cut and join location shown in **RED**). **Image middle:** Interior inspection of the welded joint(s). **Image right:** Exterior inspection of rivet-bonded areas (with coatings and sealers removed).
