REPAIRCERT NZ UPDATE

UPDATE No. 15 | 21/11/2022

Sectioning and Partial Replacement of Outer Panels

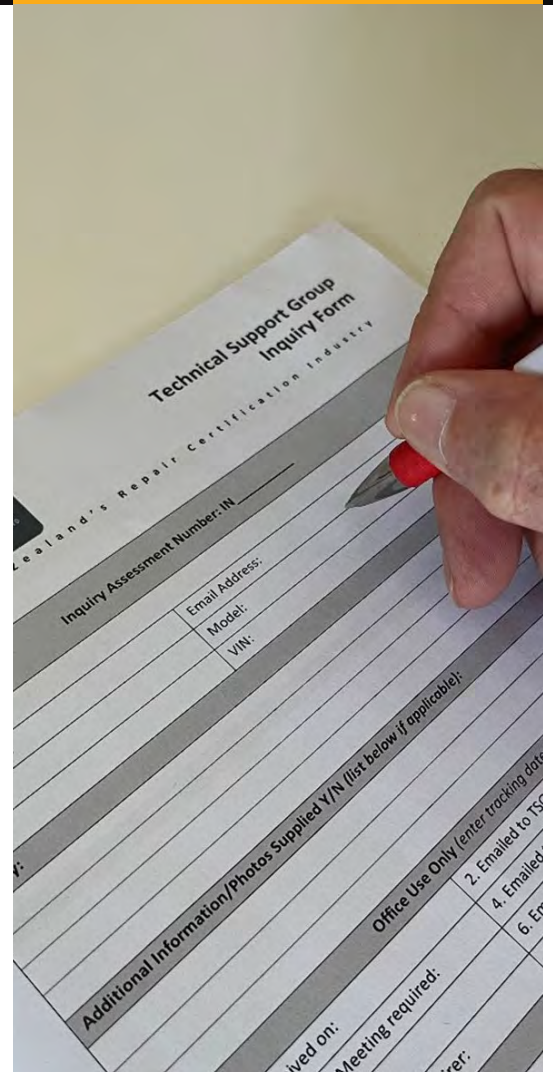
In this instance, the damaged front crush zone portion of the body-over-frame vehicle chassis had been repaired rather than replaced. Both RepairCert NZ technical staff and Waka Kotahi Certification Officers were of the opinion that crush zones are sacrificial parts and should not be repaired. Several telephone and email discussions between the Repair Certifier and RepairCert NZ failed to convince the Repair Certifier in question that the damaged crush zone should have been replaced, not repaired, and that the vehicle is potentially now unsafe and non-compliant.

Should the right front chassis rail crush zone be replaced or repaired (body-over-frame chassis rails)?

We received seven responses from a total of nine TSG members of the group (two members were unable to respond). ALL seven of those responses determined that crush zones should **not** be repaired, and that the damaged crush zone on this particular vehicle must be replaced in accordance with the replacement procedures described in the vehicle manufacturer's Body Repair Manual (BRM).

This is the second time in recent months that RepairCert NZ and Waka Kotahi Certification Officers have given a Repair Certifier clarification around the requirement that damaged crush zones cannot be repaired and **must** always be replaced. ■
